## UPPER SPINNEY FENCING SURVEY

**INTRODUCTION** - In August 2024 exploratory work was started in order to reveal the fencing running along the north eastern side of the Upper Spinney which was almost completely hidden from view from years of neglect which had allowed scrub of weeds, brambles and ivy to cover an area of approximately 200 square meters. The purpose of the clearance work was to establish the condition and extent of survival of the fencing along this section in order to prepare a comprehensive survey of the fencing. It is hoped that this fencing survey will be the first of a number of surveys of the Upper Spinney which will be part of a bid for major project funding to restore its trees, flora and fauna as well as its historic fencing.

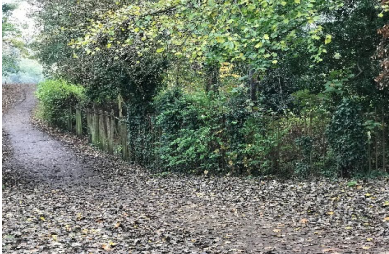
| Sections | Post (lhs) | Uprights | Condition | Images |
|---|---|---|---|---|
| 1 ✓ | | Complete | <p>The first section of the fencing was damaged some time in the past and the horiz rail has been wired up to the post.</p> | <p>Fencing in November 2021</p> |

| Sections | Post (lhs) | Uprights | Condition | Images |
|---|---|---|---|---|
| 1.5 | | (15- not counted as can be reused elsewhere ) | <p>There is a gap for 3 bars before the next section which has been filled with a 15 bar section. This is attached with an old clamping repair to uprights. The lhs post is missing.</p> | <p>Note: This 15 bar section could be reused elsewhere if the rail to the first section is reconnected to the first post.</p> |

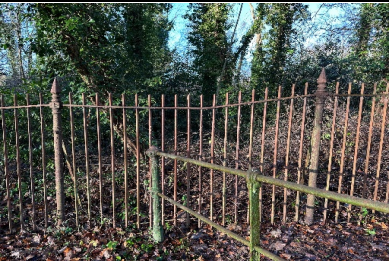
| Sections | Post (lhs) | Uprights | Condition | Images |
|---|---|---|---|---|
| 5 ✓ | | Complete | <p>The cattle fence intersects with the centre of this section. Horiz bar bends slightly where the ground dips.</p> | <p>Section 5</p> |

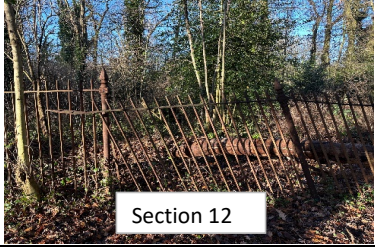
| 12 | ✓ | 16 | Skewed to lhs | |

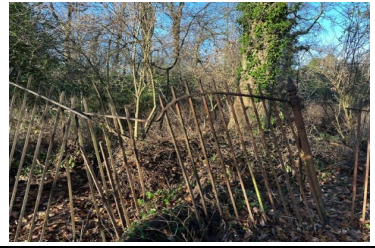
| 15 | ✓ | 17 | Heavy damage. 2 uprights detached and forced into ground by fallen tree | |

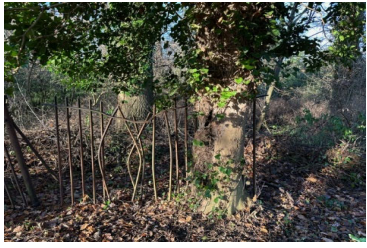
| 16 | ✓ | Complete | Section runs behind large oak tree. | |

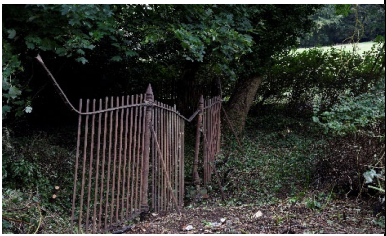
| 30 | ✖ | 13 | Post missing but base of post visible in the ground. Retaining horizontal top bar bent upwards. The diagonal stays now on the outside of the fencing. | |

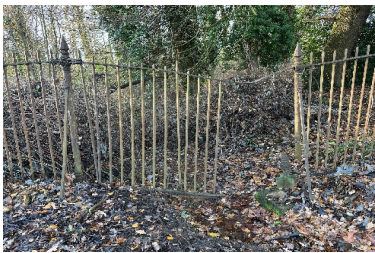
| 31 | ✓ | 13 | The first of the 2 springs from the park runs through this section. Three upright sections recovered within the Spinney buried in the stream. An iron bar 'gate' placed across the stream to act as a barrier. | |

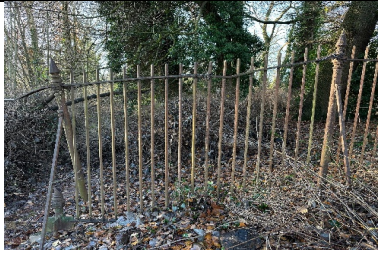
| 32 | ✓ | Complete | Bottom of post cemented into block with crack at the base of the post. | |

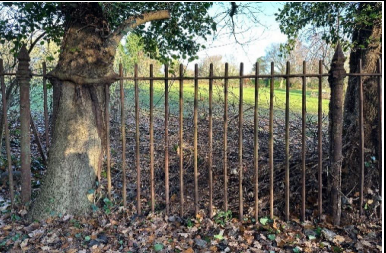
| 34 | ✓ | Complete | End of the section as it approaches post embedded into tree | |

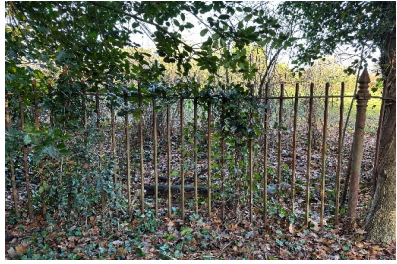
| 35 | ✓ | Complete | Good condition. This is where uncovering work to the fencing stopped our work on the fencing and all the fence sections along this northern facing side are hidden by thick undergrowth and ivy. | |

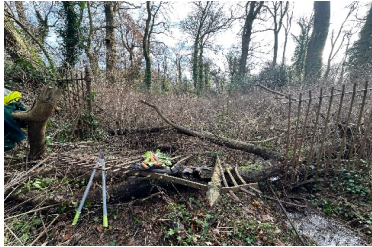
| 60 | ✓ | 0 | An almost complete section of detached fencing lies on ground of 17 bars brought down by falling branches in 2020. | |

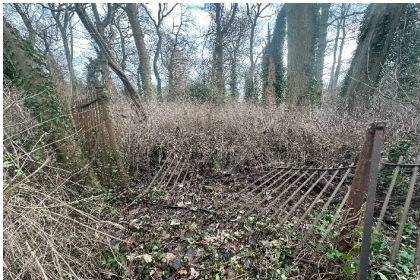
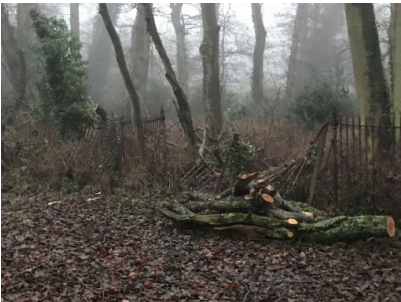
| 65 | ✓ | | <p>Detached section with 18 bars on ground from fallen branches. Post broken at top but complete.</p> | <p>Storm damage to fencing in Dec 2021</p> |

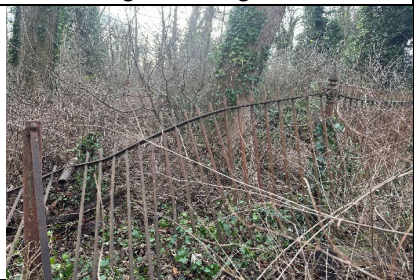
| 66 | ✓ | Complete | <p>Damaged section from Dec 2021 storm, bent back into the Spinney but still standing. Post split at top with bottom section still in situ.</p> | |

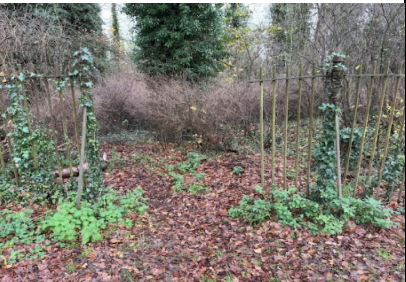
| 80 | ✓ | | 6 The old entrance to the spinney with gate missing (now in lock up) | |

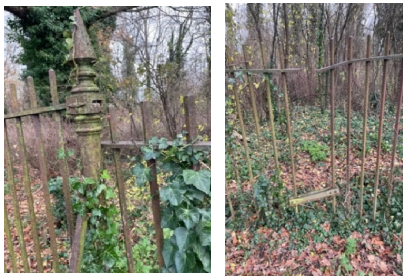
| 82 | ✓ | 17 | <p>Top rail is dislodged to LHS and broken in middle. Old clamp repair to uprights. Image is taken from inside Spinney looking out.</p> | |

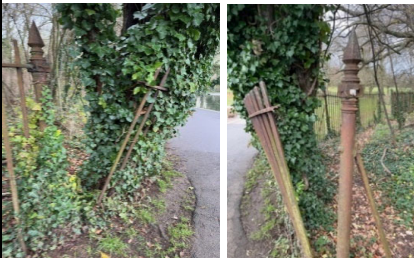
| 84 | ✓ | Complete | <p>Tree by lake has broken the fencing and forced it out towards the fishing lake.</p> | |

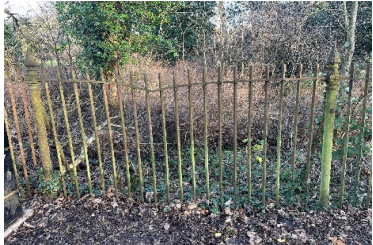
| 94 | ✓ | Complete | Horizontal top rail bent slightly in middle | |

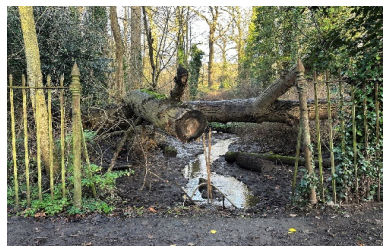
| 113 | ✓ | | Section badly damaged by fallen tree from storm damage of 19 February 2022. This is where the conduit passes under the main path. | |

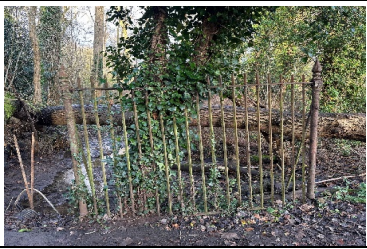
| 114 | ✓ | Complete | Fair condition | |

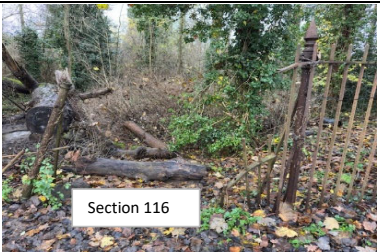
| 116 | ✓ | 5 | The uprights have been rammed into the ground by the falling tree. Post bent and missing top. | |
